Contract #: 04-0120F4Cty: SF/ALA Rte: 80 PM: 13.2/13.9File #: 99.28**WELDING INSPECTION REPORT****Resident Engineer:** Casey, William**Address:** 333 Burma Road**City:** Oakland, CA 94607**Report No:** WIR-029564**Date Inspected:** 06-May-2013**Project Name:** SAS Superstructure**OSM Arrival Time:** 700**Prime Contractor:** American Bridge/Fluor Enterprises, a JV**OSM Departure Time:** 1530**Contractor:** USA Hoist**Location:** USA Hoist, Crest Hill, IL**CWI Name:** None present**CWI Present:** Yes No**Inspected CWI report:** Yes No N/A**Rod Oven in Use:** Yes No N/A**Electrode to specification:** Yes No N/A**Weld Procedures Followed:** Yes No N/A**Qualified Welders:** Yes No N/A**Verified Joint Fit-up:** Yes No N/A**Approved Drawings:** Yes No N/A**Approved WPS:** Yes No N/A**Delayed / Cancelled:** Yes No N/A**Bridge No:** 34-0006**Component:** Elevator Cab frame assembly**Summary of Items Observed:**

WELDING INSPECTION REPORT

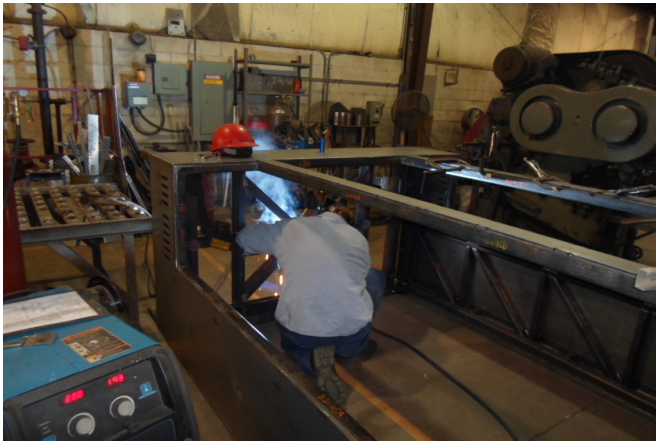
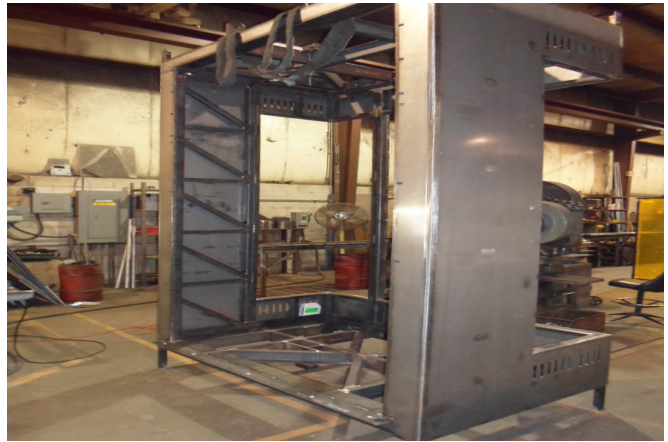
This QAI observed the welding performed and completed of the sheetmetal skin strips (2 total) item #3 to outer-face back side of the composite boxed-shape member formed from bent-plate channel members #27 and #58 assembled in a toe-to-toe configuration. For these areas of welding, WPS FCAW-3139 was utilized. This QAI monitored the in-progress welding parameters, verifying adherence to the approved WPS. The welding was

This QAI witnessed the welding performed and completed of stabilizer mounting plate item #62 to C4x5.4 channel #11 where the weld was initially found deficient in it's throat size. The welding of these items was per WPS FCAW-3133. The welding was observed and verified by this QAI and appeared to be in compliance with the contract documents.

All of the remaining required welding of the Elevator Cab frame assembly has been performed and completed this day. All of the welding of this assembly appears to comply with the contract documents.
